**NASA TECHNICAL
MEMORANDUM**

NASA TM X-52290

CENTAUR AC-6 NOSE FAIRING SEPARATION TESTS

by Jack C. Humphrey and Charles W. Eastwood, Jr.

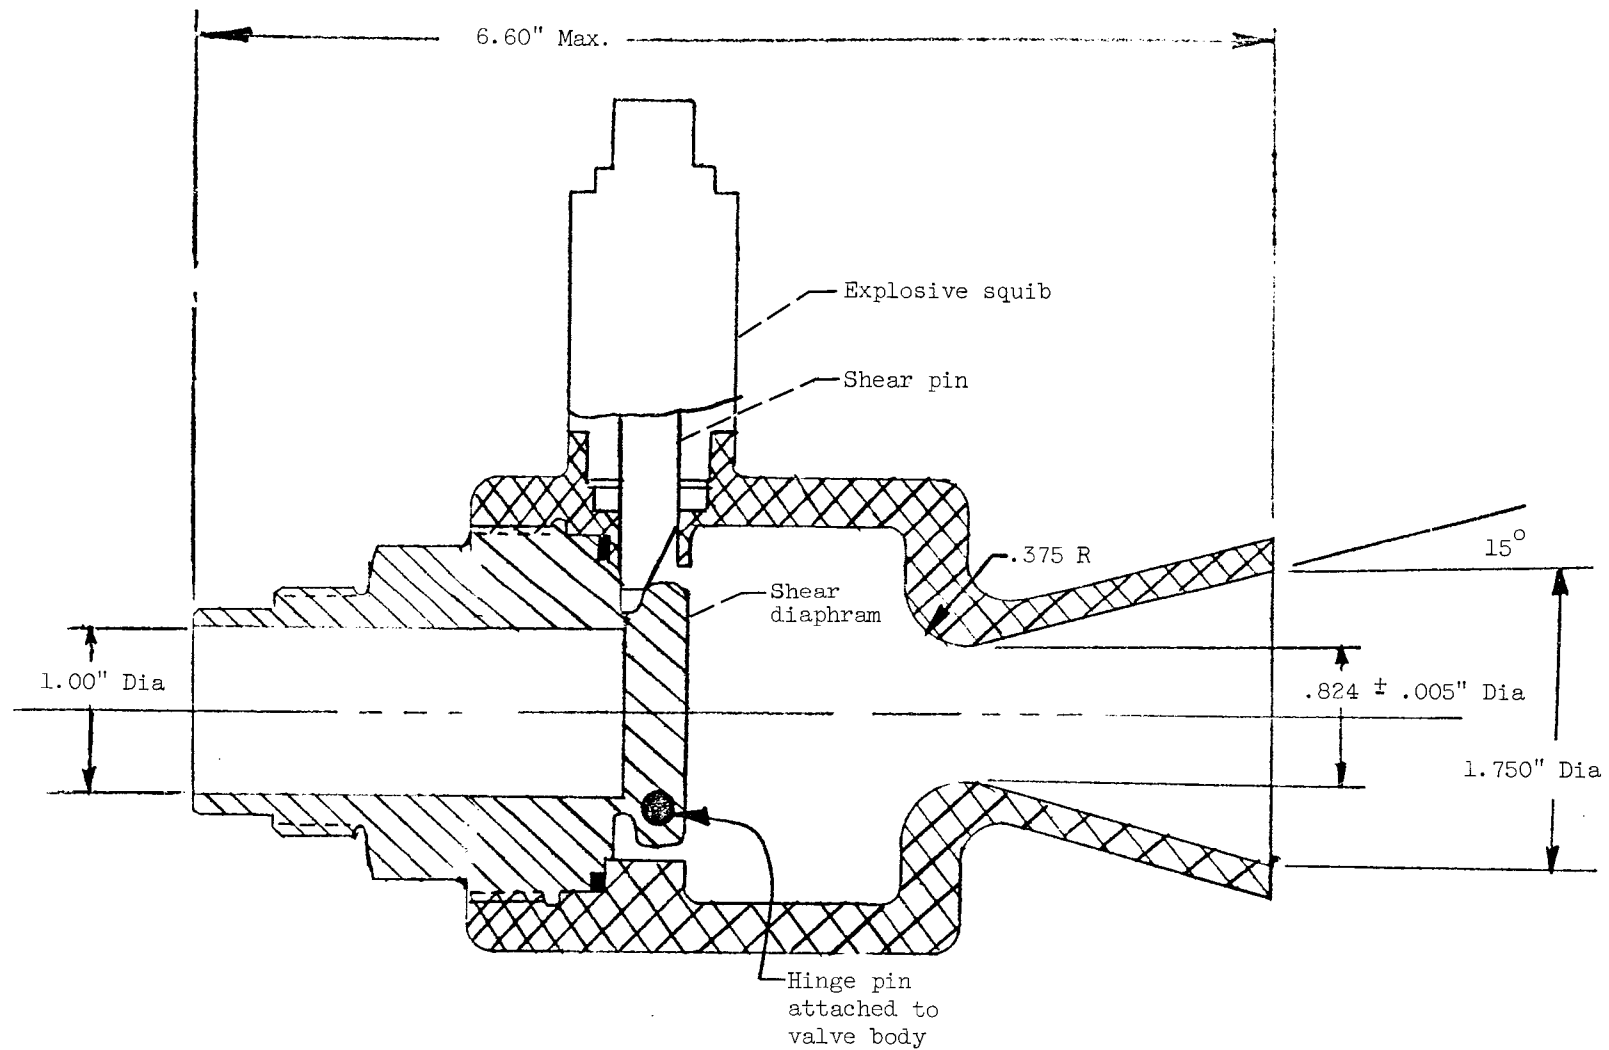
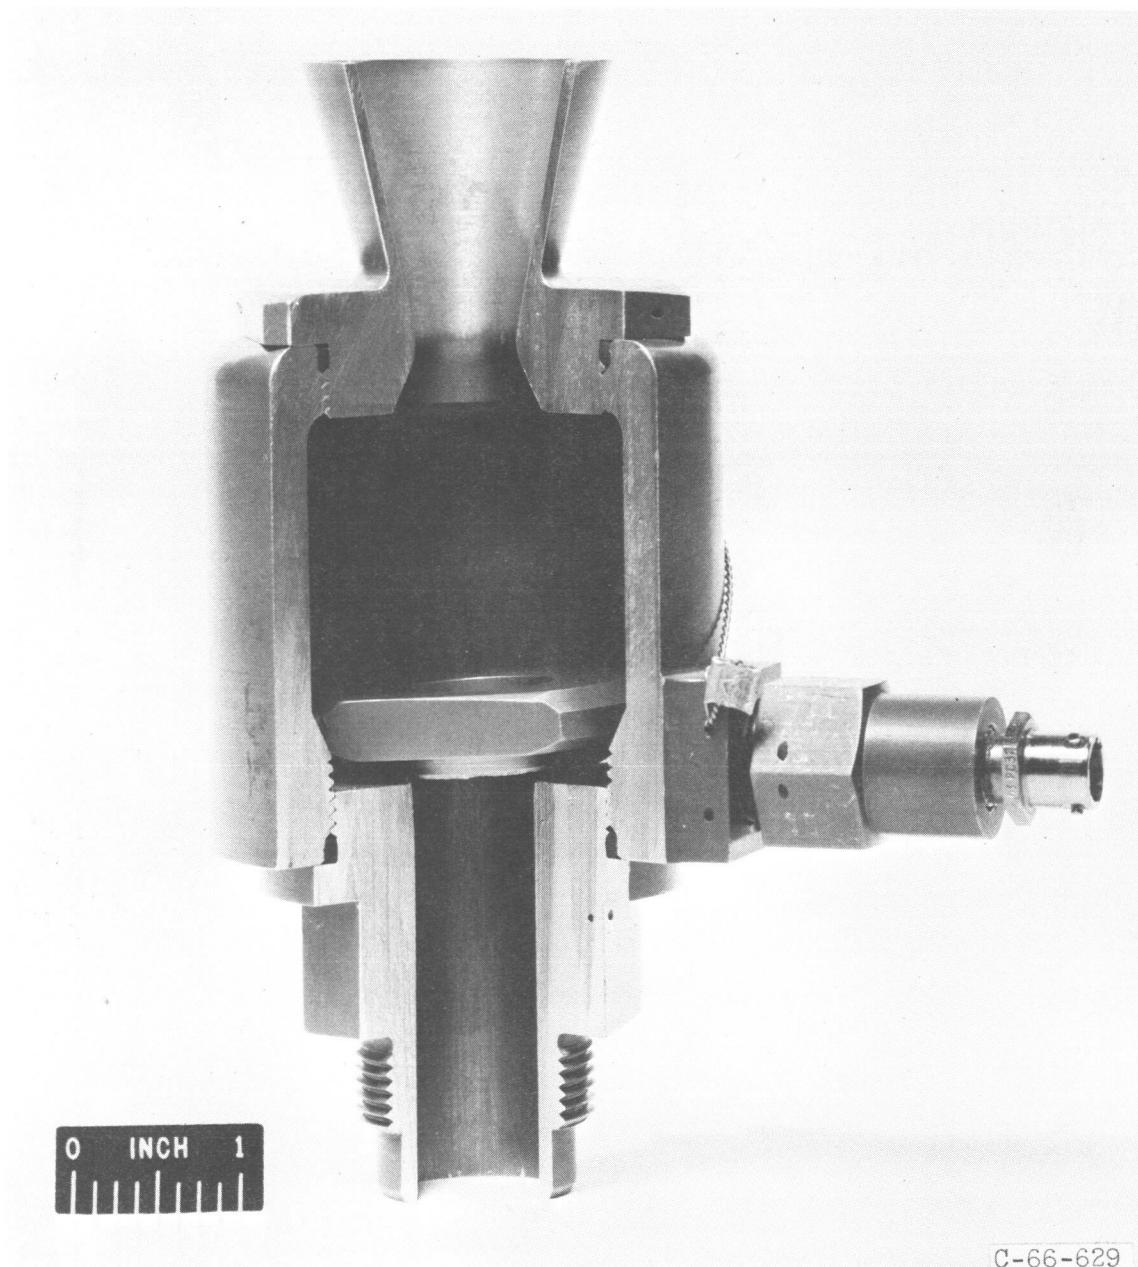
Figure 1. - Jettison bottle pyrotechnic valve and nozzle.

The thruster bottle nozzle and valve assembly shown in figure 1 replaced the design used on the AC-4 vehicle so as to eliminate possible metallic shrapnel. In all tests, the valve operated perfectly. No shrapnel was evident and no failures of the pyrotechnic actuated shearing pin occurred.

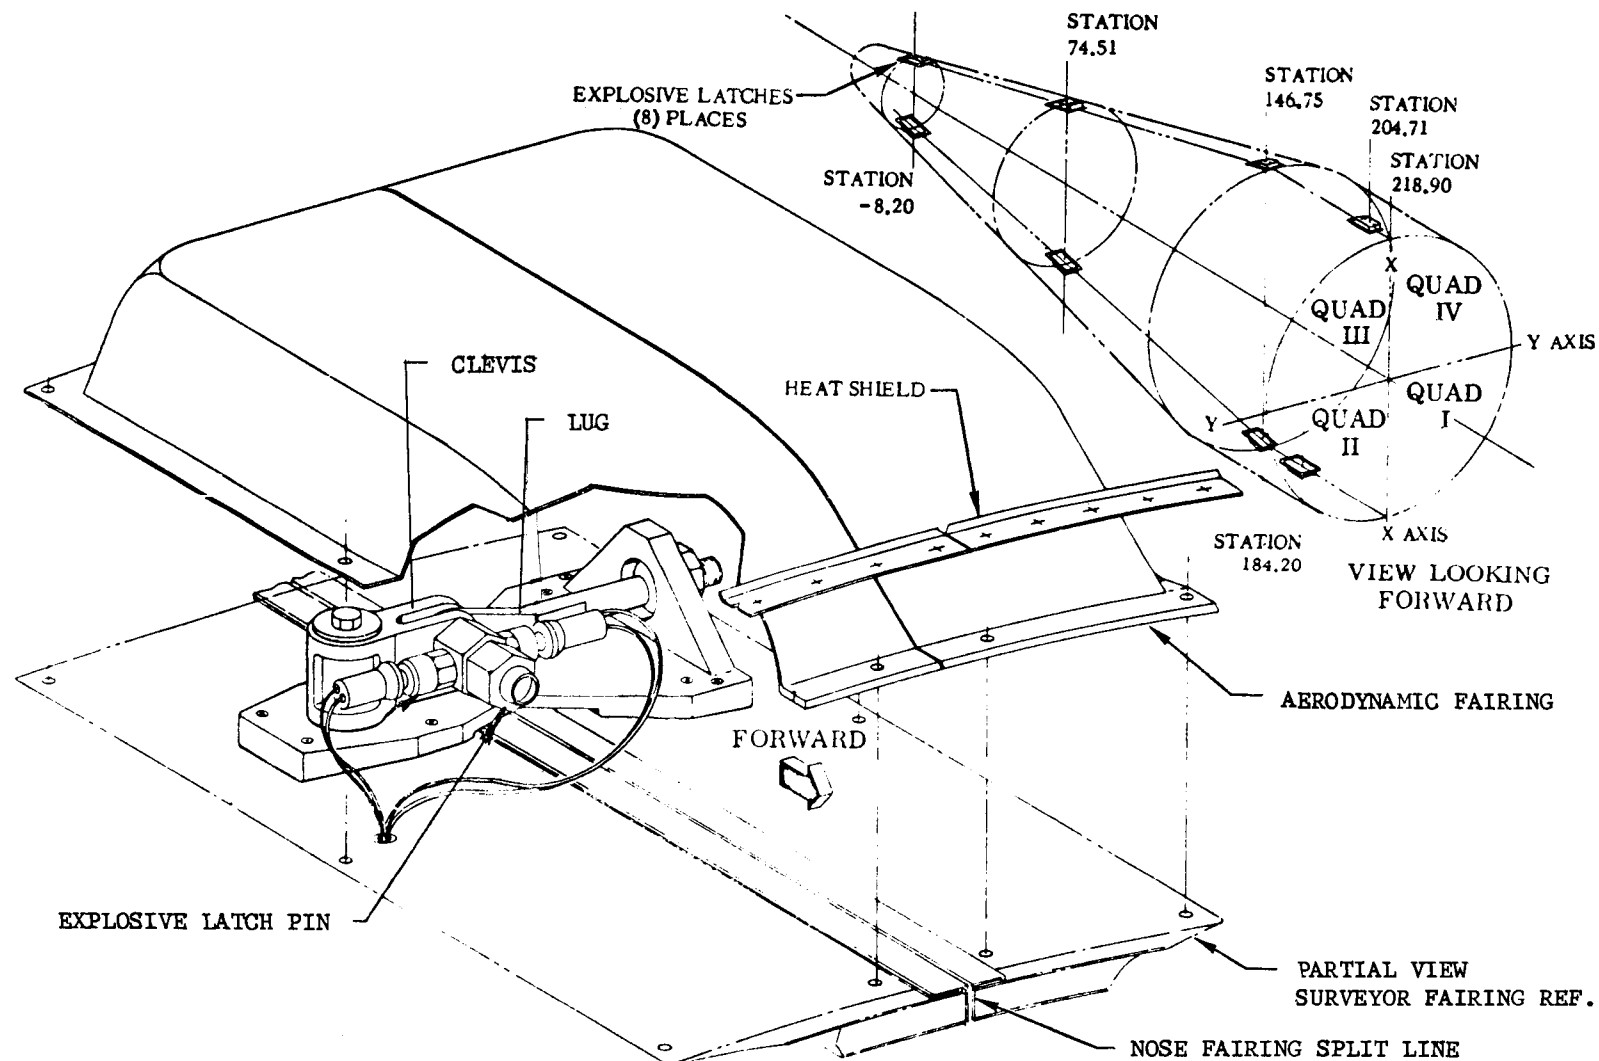
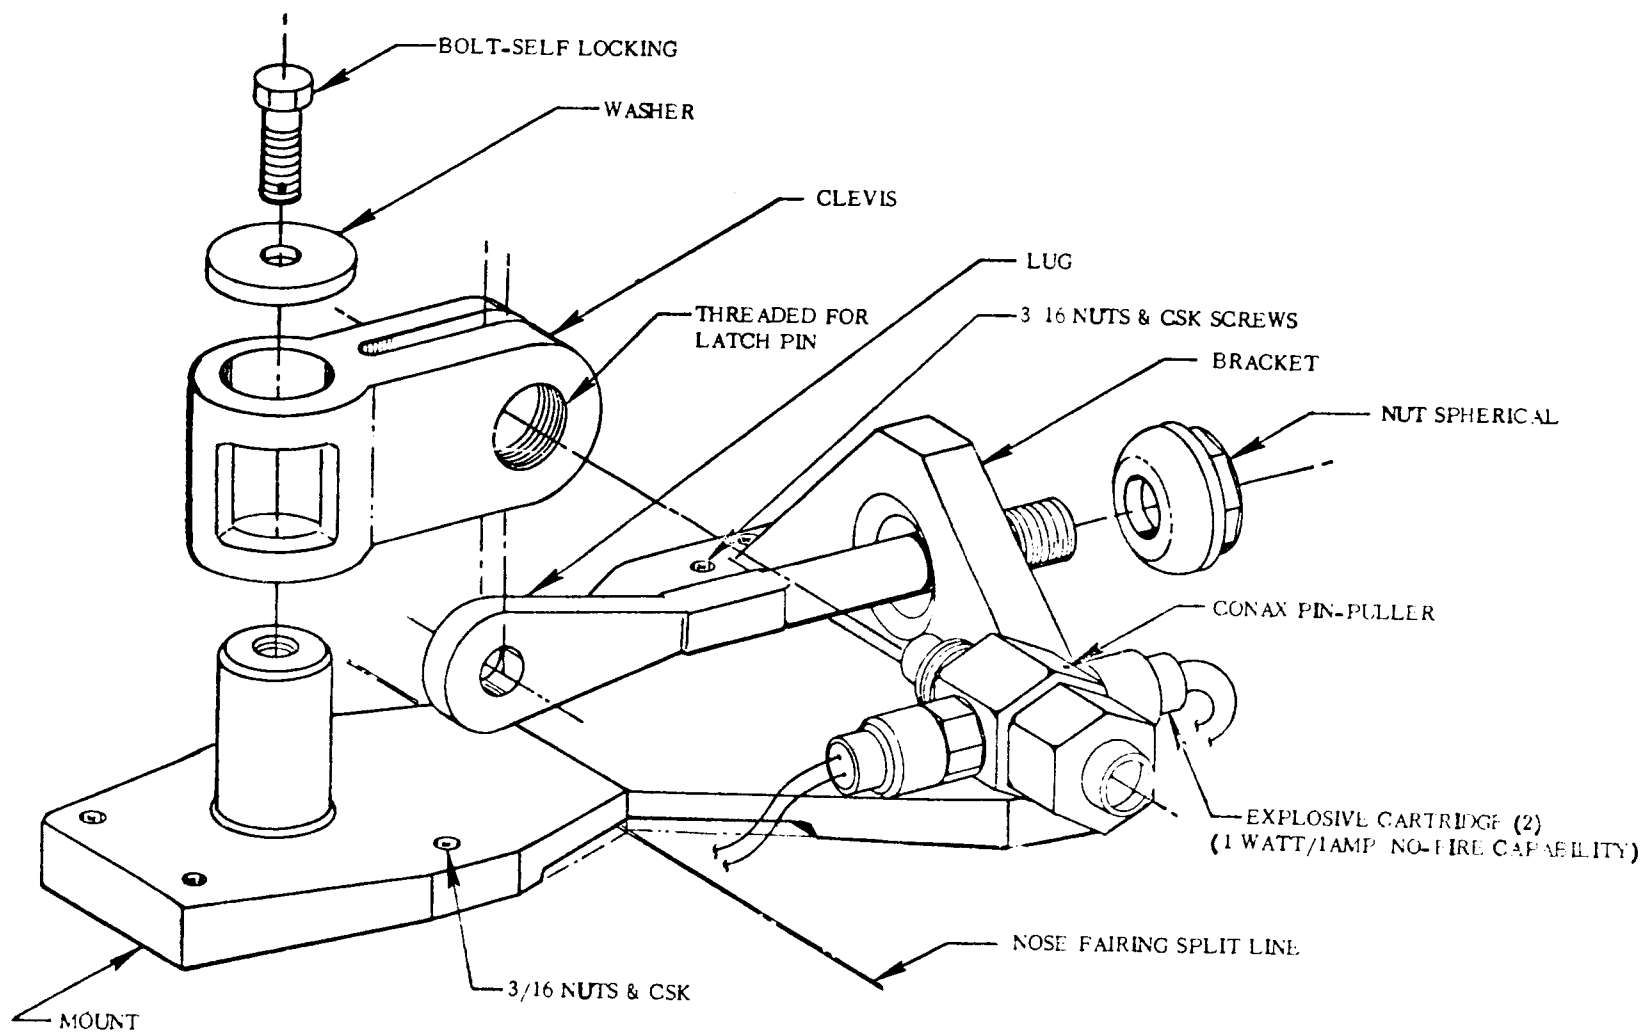
Figure 3. - Separation latches.

The redesigned split line latches are shown in figure 3. In all tests of the latches, operation was without failure. No shrapnel from the latches was observed; however, in assembly of the latches, the lug and nut galled on one latch and interference between the pin puller and the clevis was noticed on two other latches. Better inspection, closer tolerances, and better lubrication eliminated these difficulties on the remaining tests.

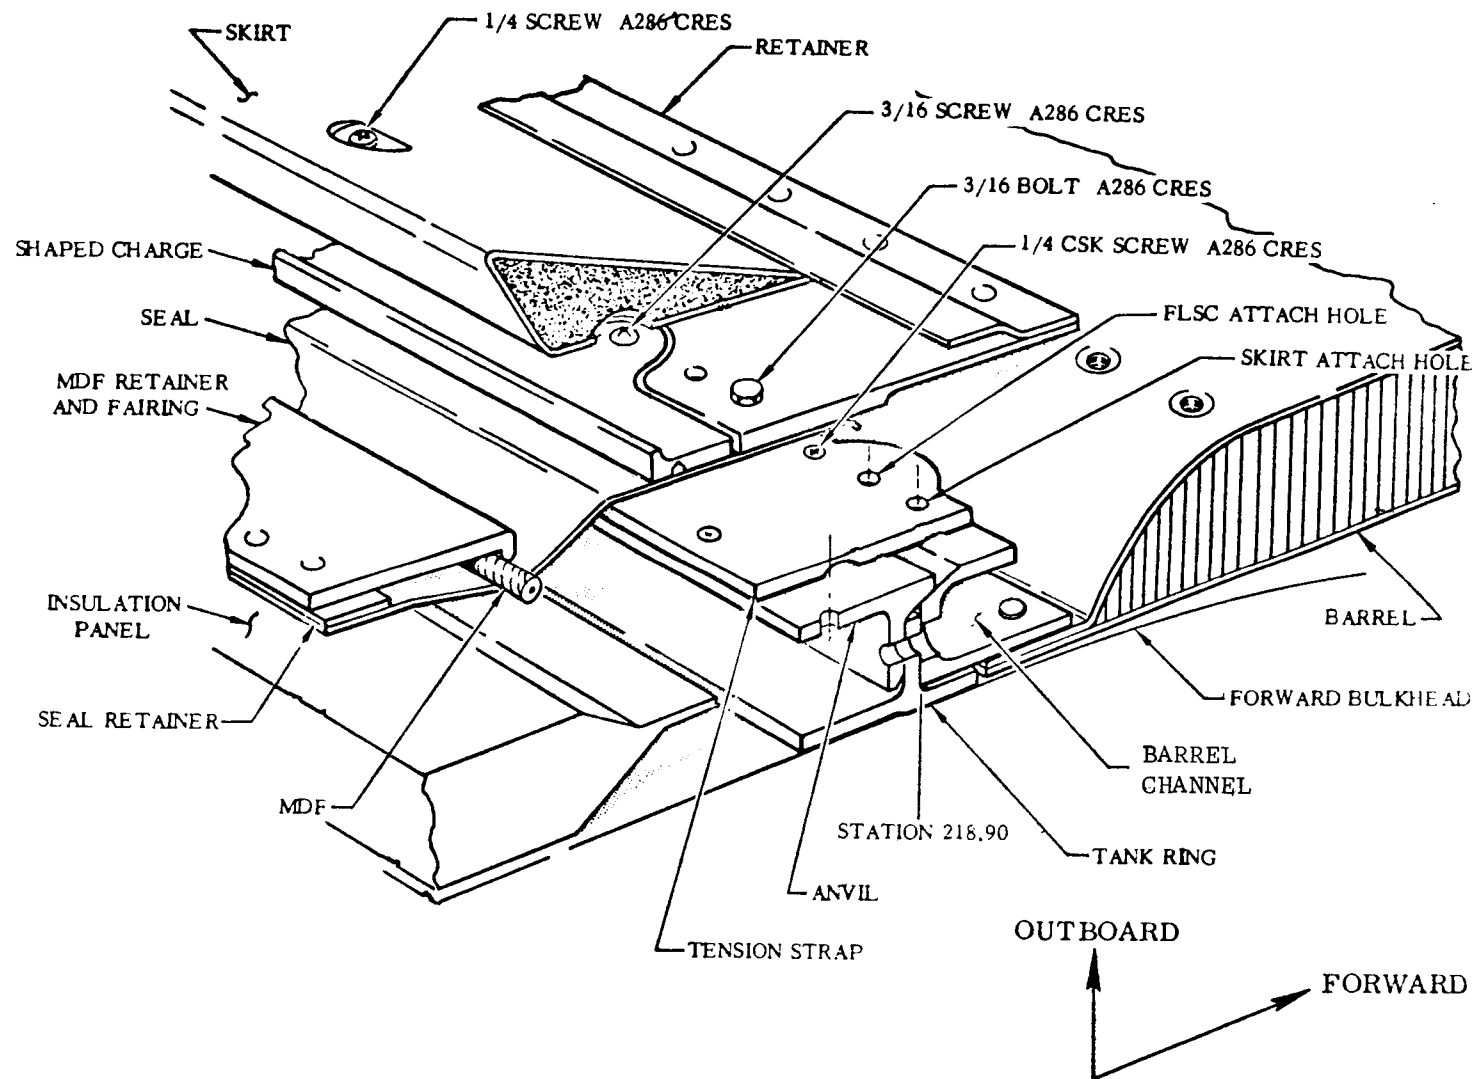
Figure 10. - Station 218.90 areas installation.

Although the shaped charge completely separated the fairings from the vehicle, it also caused damage to the skirt assembly (a plastic structure protecting the shaped charge) as shown in figure 10. The effect of the explosion was to force the skirt outward and thus to shear inserts. These inserts were glued to the foamed plastic body of the skirt and were used to provide bearings for the bolts holding the skirt to the 219 ring. Figure 43 shows the developed surface of the skirts used in each of the tests and indicates the position of each of the bolt-insert points on the skirts. This figure lists all damage seen after each of the shaped charges were fired. As can be seen in test LA-1A and LA-2A, very few of the inserts were intact after the test. In test LA-1A five of the insert-bolt points were undamaged and in test LA-2A, eleven were undamaged. Damage varied from partial cracking of the glue joint between the insert and the skirt body as shown by the symbol marked "incipient failure" to bolts completely blown from their thread fasteners or inserts with no effective glue joint, as shown by the symbol marked "failure". Test LA-2B was made with the skirt body used in test LA-2A. New inserts were glued in the skirt using a mixture containing 50

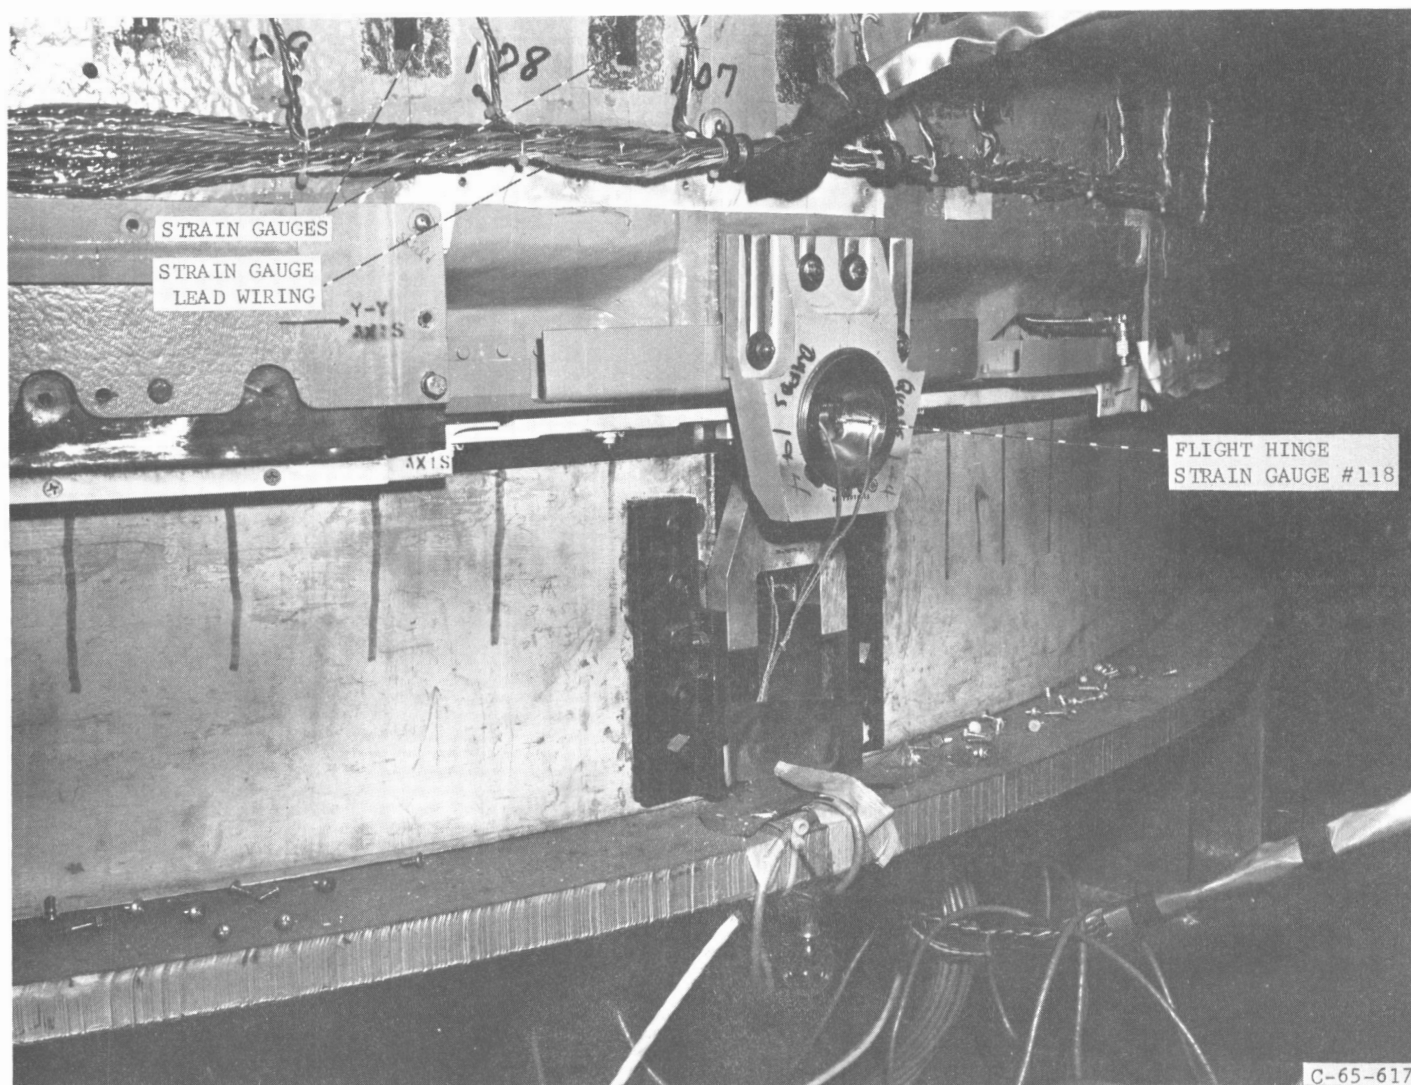
(a) Without metal protective sheet.

Figure 28. - Fairing strain gauge installation.

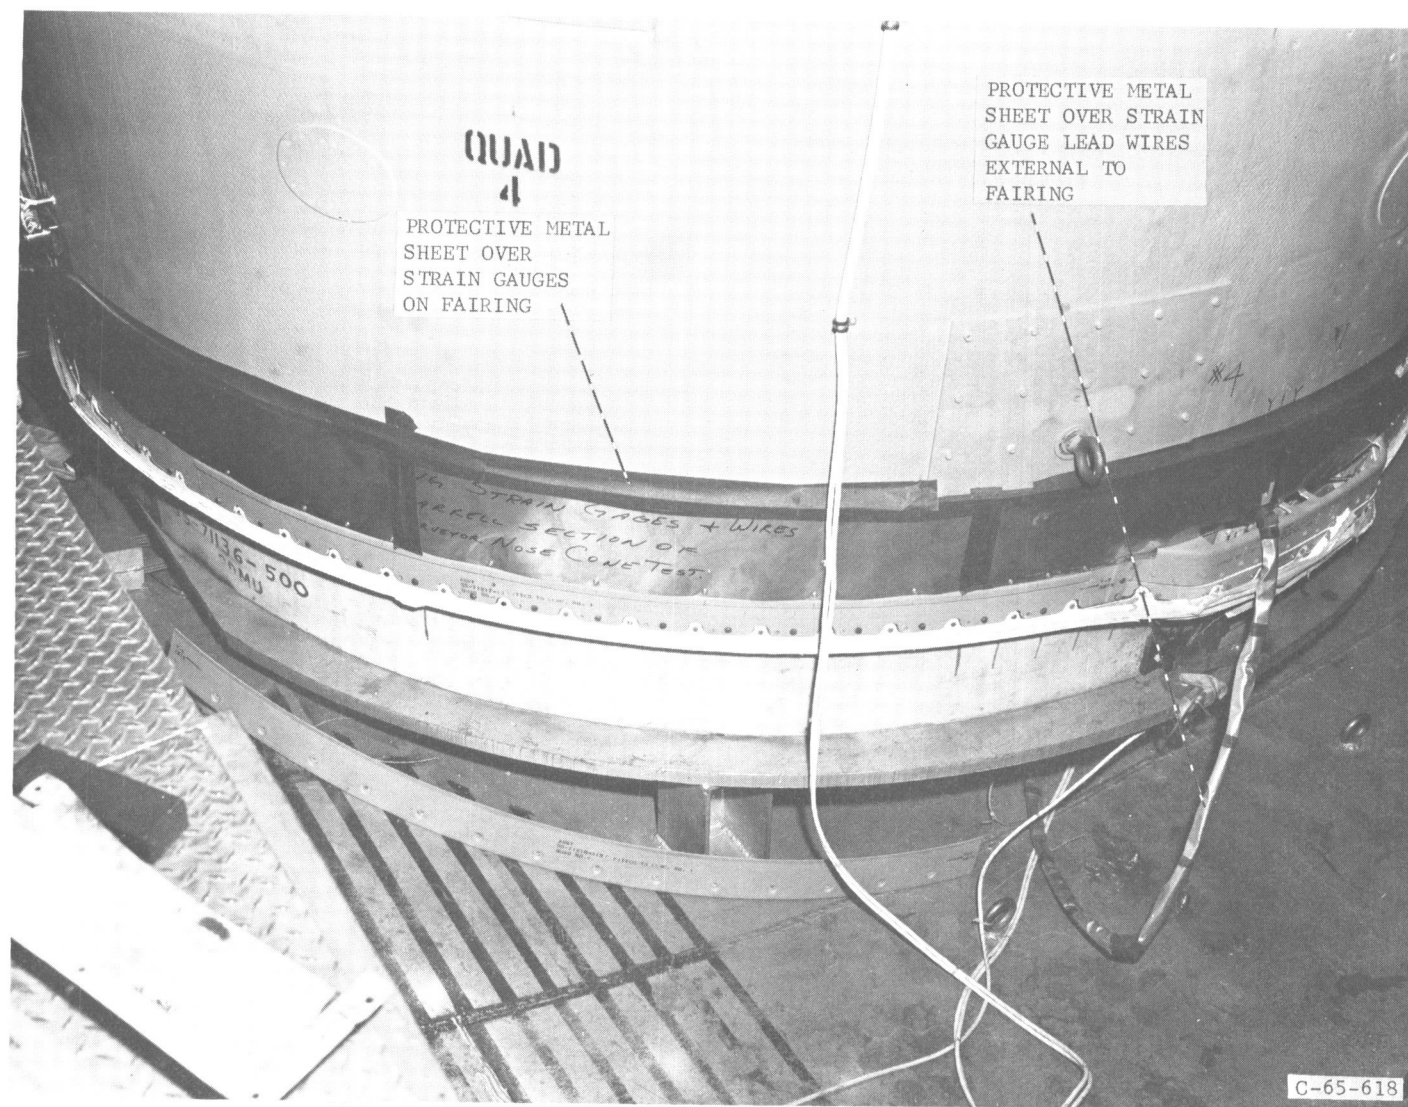
(b) After installation of protective metal sheet.

Figure 28. - Concluded. Fairing strain gauge installation.

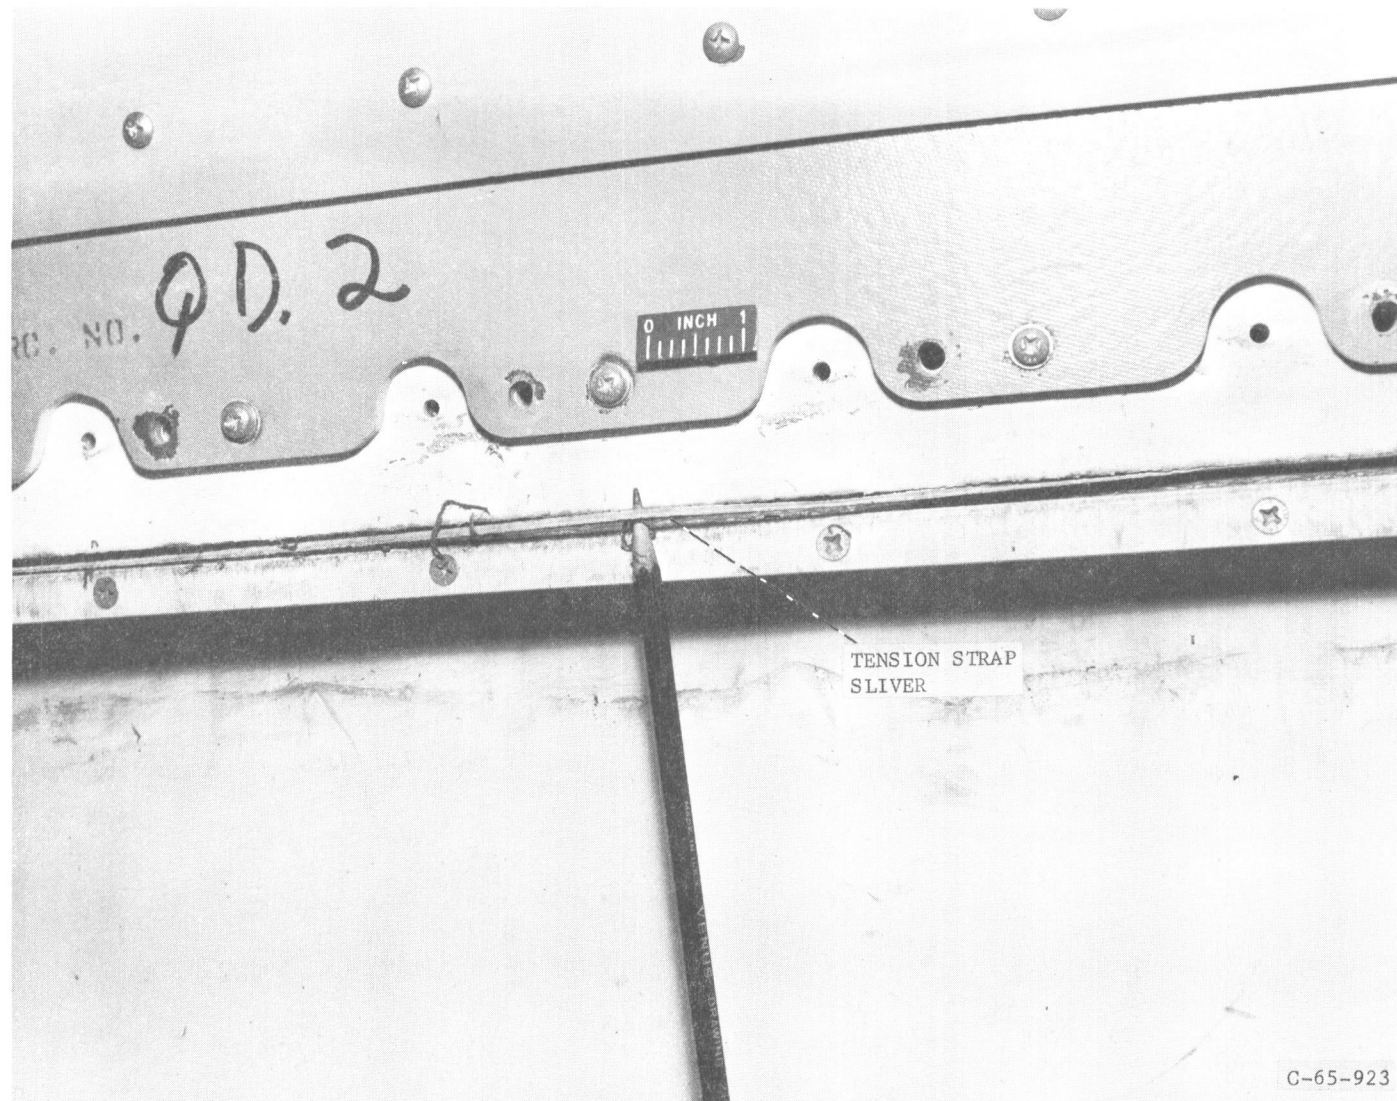
Figure 42. - Sliver of metal formed by the cut made on the tension tie by the firing of the shaped charge, test IA2-A.
